## CONDITION REPORT

IPSWICH BOROUGH MUSEUMS  
AND GALLERIES

Exhibition Title: 'Henri Fantin-Latour and the Impressionists: Still Life  
Painting in the 19th Century'

' Still Life with Fish'
-------------------------

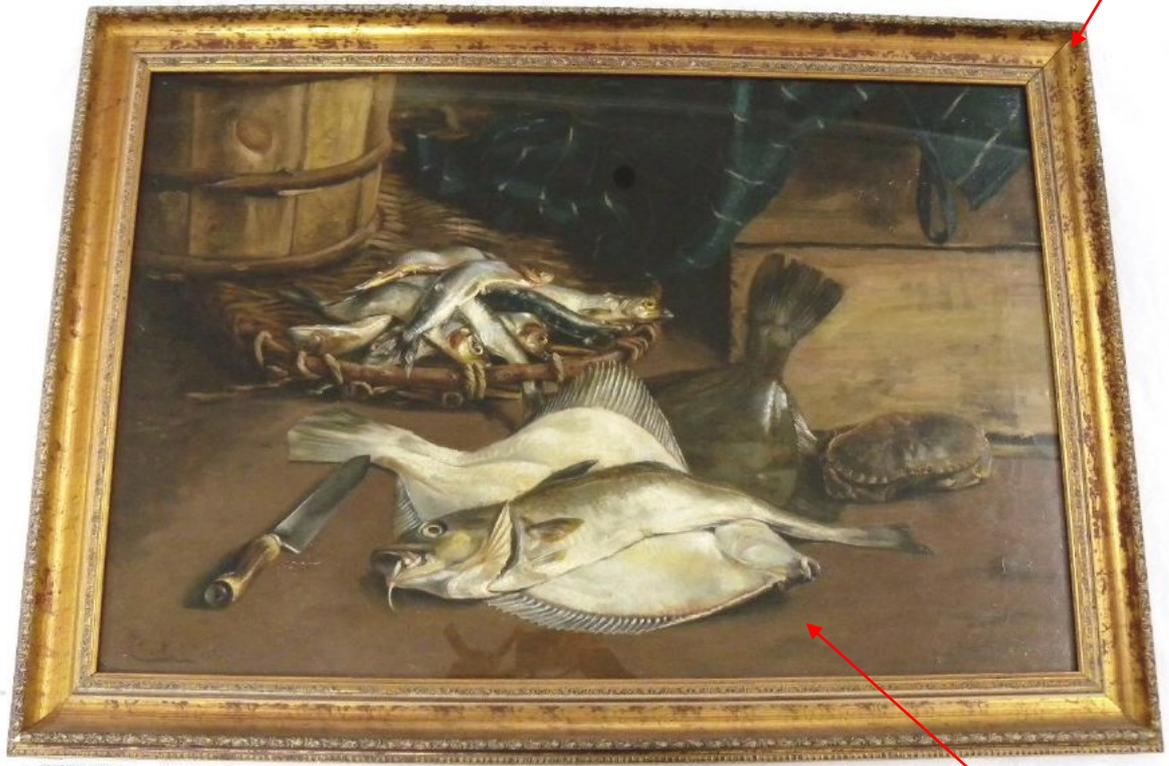
Mortice  
slightly opened

Canvas in frame (front)

Hole

White paint  
mark

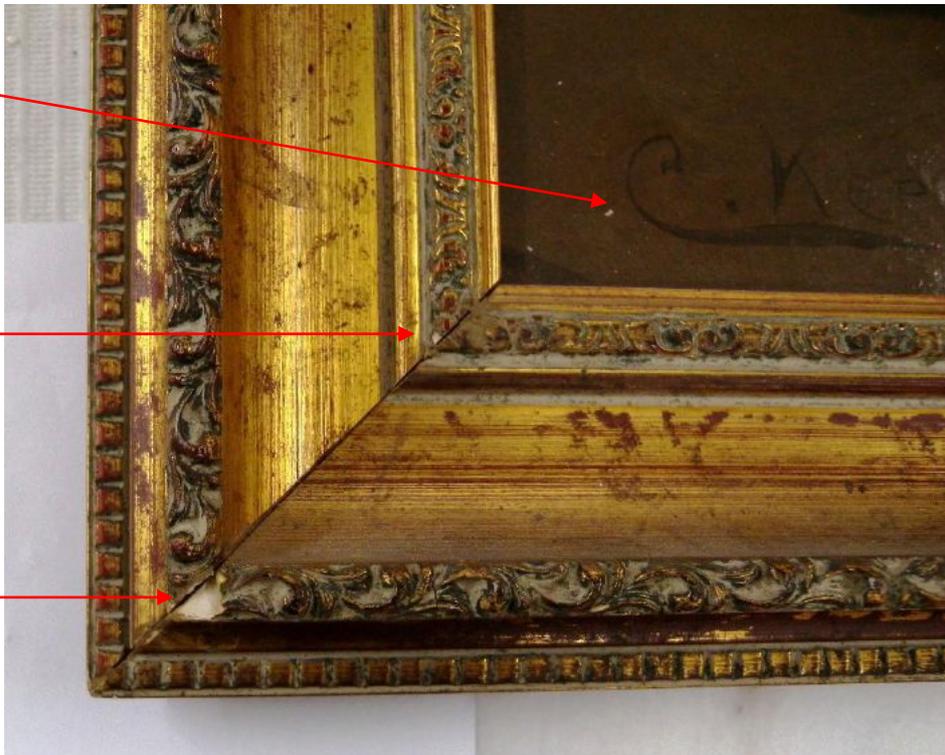
Losses to moulding on front bottom proper right corner of top edge and foliage strip.

Losses to moulding on top edge and foliage strip, bottom proper right corner.

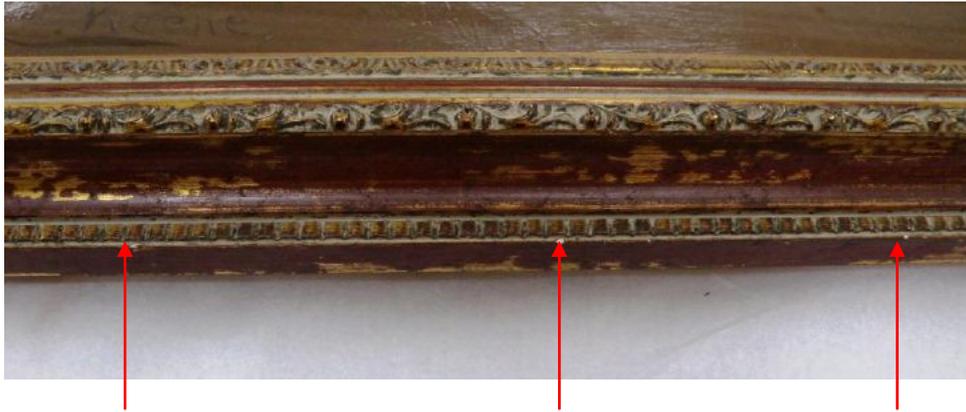
Minor losses to gilding on back edge of bottom rail (approx. 170, 280, 385mm from bottom proper right corner); back edge of proper left rail (approx. 10, 40mm from bottom proper left corner); back edge of top rail (approx. 20, 100mm from top proper left corner).

Losses to gilding on back edge of bottom rail.

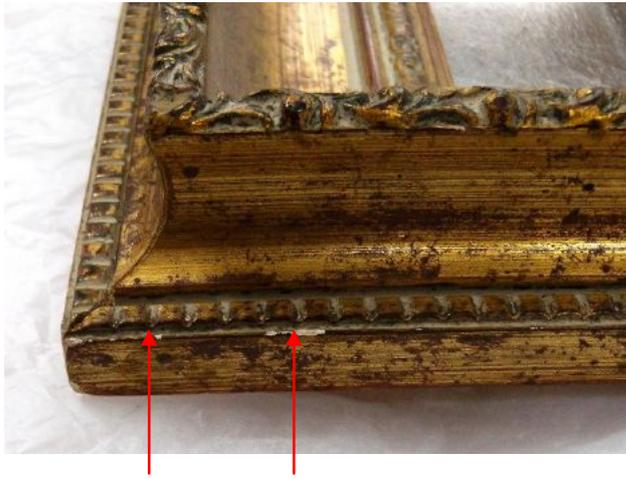
Losses to gilding on back edge of proper left rail.

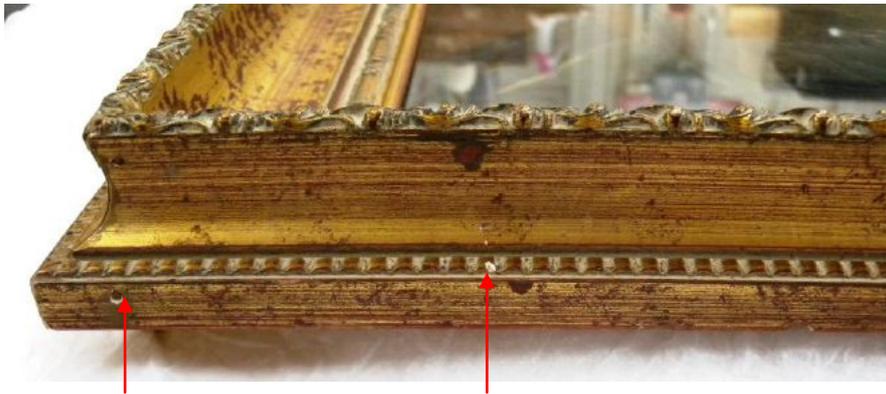
Losses to gilding on back edge of top rail.

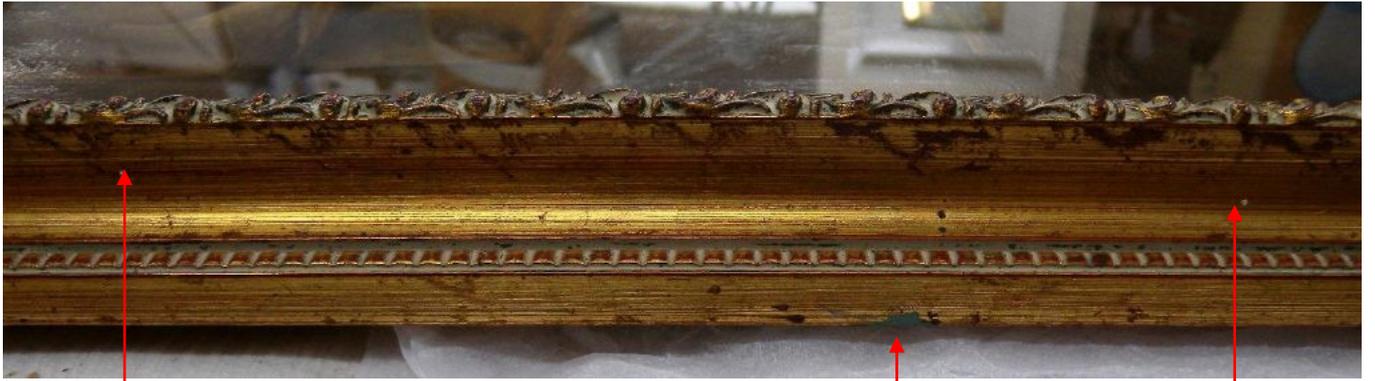
Spots of white paint on surface of gilding in back hollow of proper right rail (approx. 200, 440mm from top proper right corner). Green paint mark on surface of gilding of back edge of proper right rail (approx. 360mm from top proper right corner).

Spots of white and green paint on proper right rail.

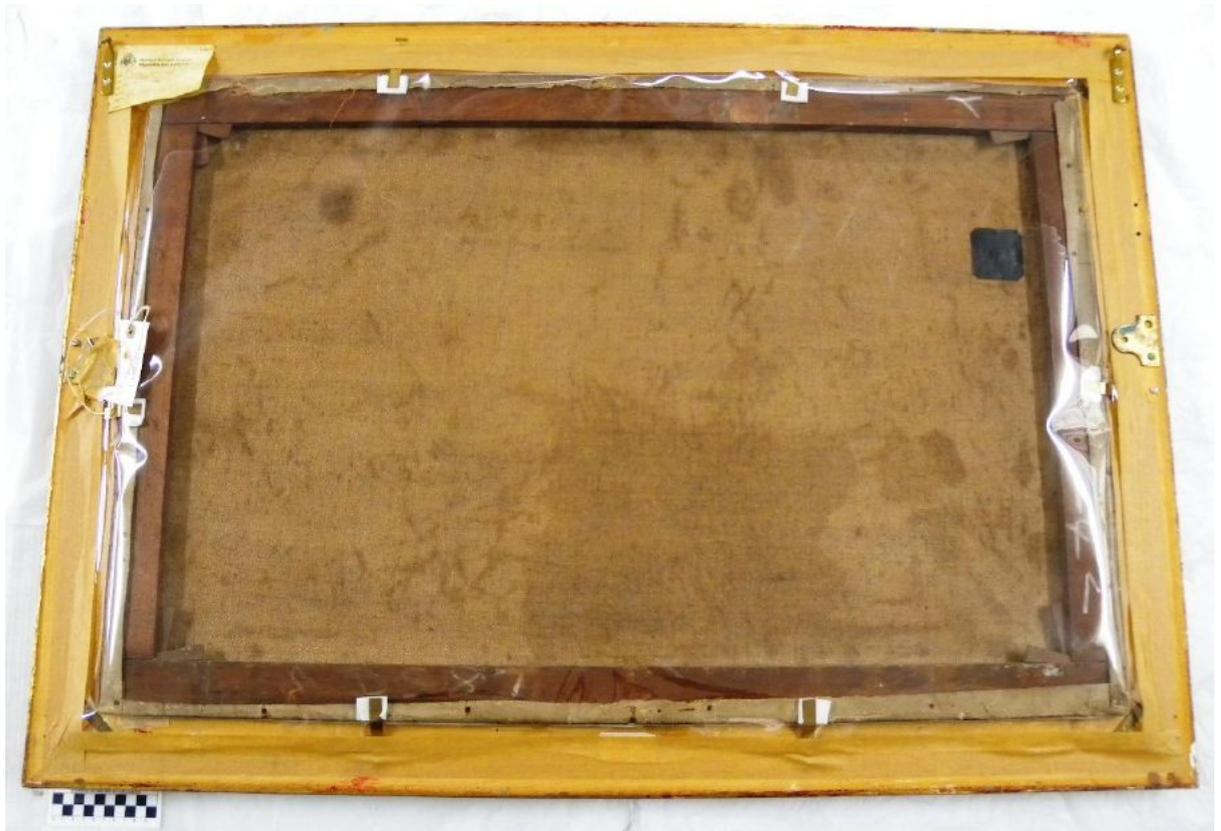
Canvas in frame (reverse) showing Melinex backing, sealed with picture tape.

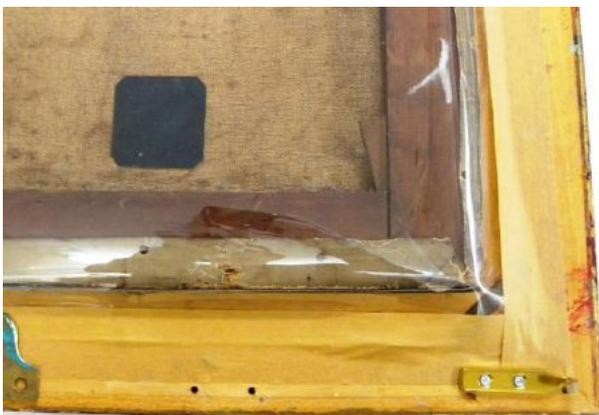
Patch on reverse of canvas in top proper right corner (approx 150mm from top edge of canvas, 70mm from proper right edge of canvas. 50mm x 50mm).

Patch on reverse of canvas, top proper right corner.

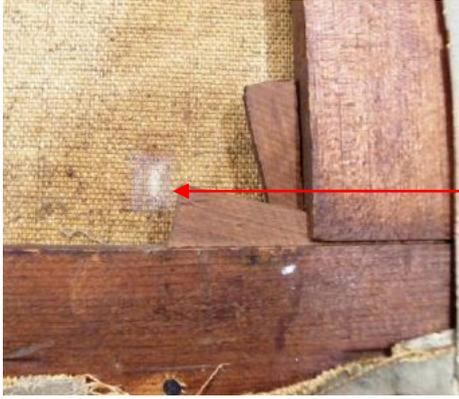
Previous repair on reverse of canvas in top proper left corner (approx. 60mm from top of canvas, 90mm from proper left edge of canvas).

Previous repair on reverse of canvas, top proper left corner.

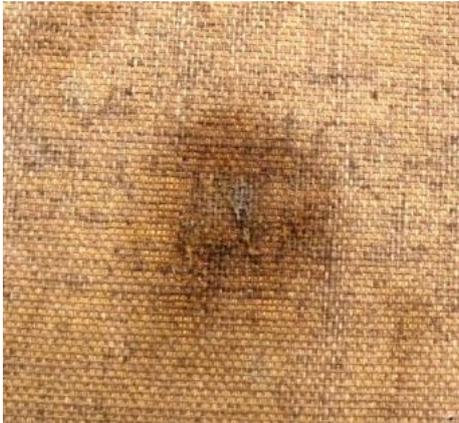
Mark on reverse of canvas, top proper left corner.

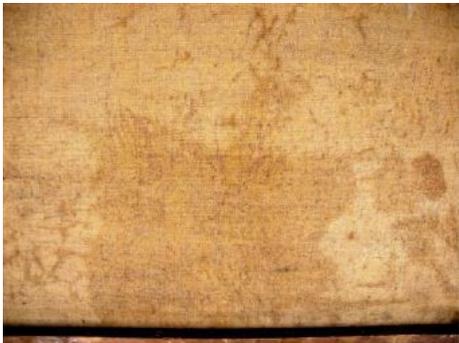
Canvas marked/stained in areas along bottom edge and in top proper left corner.

Mark(s) on reverse of canvas, centre bottom edge.

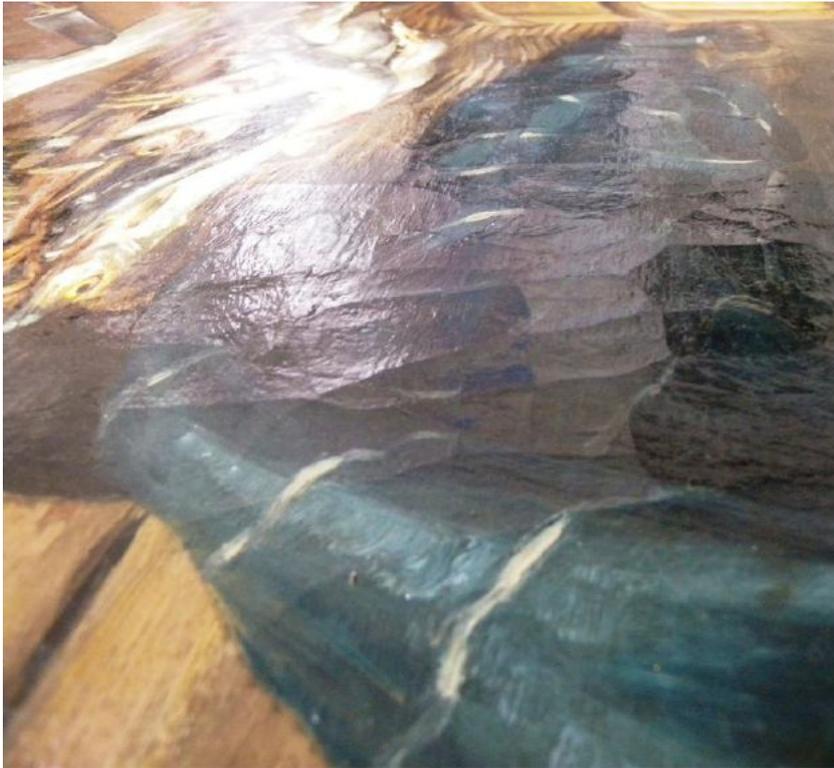
Paint surface cupped across all areas of canvas.

Detail of cupped surface of paint layer.

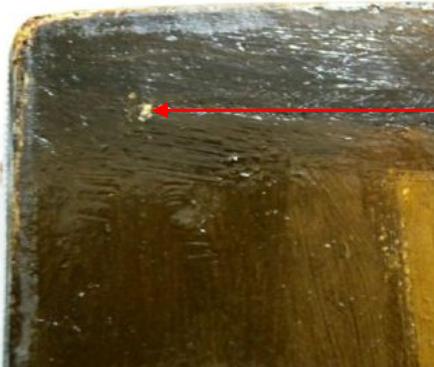
Loss in paint layer, top proper right corner.

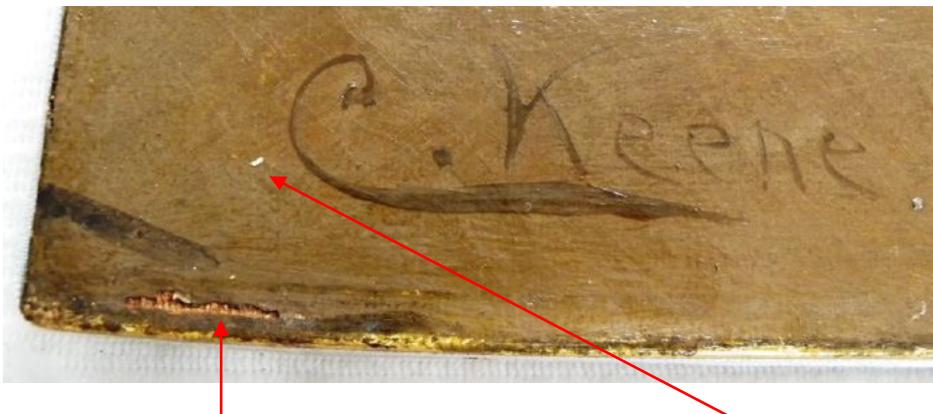
Loss in paint layer, bottom proper right corner.

White paint mark

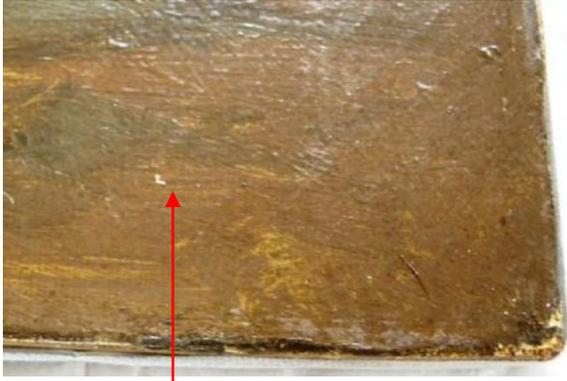
Loss in paint layer, bottom proper left corner.
