## CONDITION REPORT

IPSWICH BOROUGH MUSEUMS  
AND GALLERIES

Exhibition Title: 'Henri Fantin-Latour and the Impressionists: Still Life  
Painting in the 19th Century'

' Still Life with Fish'
-------------------------

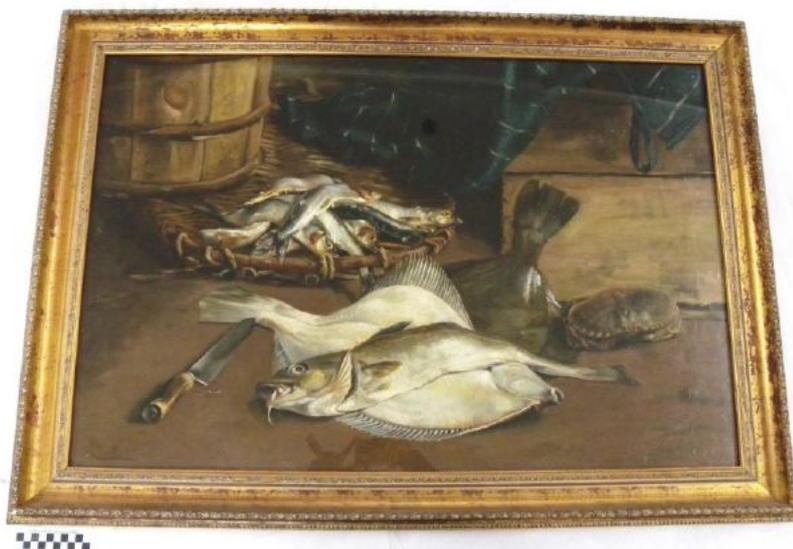
Gilding worn.

One of two top proper right stretcher pegs missing.

Previous repair on reverse of canvas in top proper left corner (approx. 60mm from top of canvas, 90mm from proper left edge of canvas).

Canvas marked/stained in areas along bottom edge and in top proper left corner.
